Upper Stillwater River Assessment

Prepared by:
Warren Kellogg
Stream & Watershed Consulting
38 Hidden Valley Drive, Clancy, MT 59634
March 2014

Stillwater Valley Watershed Council
and
Stillwater Conservation District

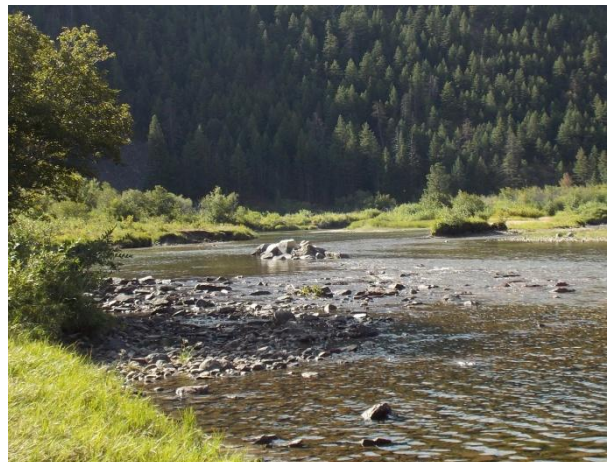
Old rock rip-rap flanked by the river is now in the middle of the active channel. The intent of the rip-rap was to protect an irrigated hay field on the east side of the river. The field is no longer irrigated and is currently used as dryland pasture. The rock in the channel is not causing any major problems, although it could pose a safety hazard for floaters.

Old rock rip-rap in the middle of the river.

Recommendation: Remove the old rock rip-rap from the middle of the river.

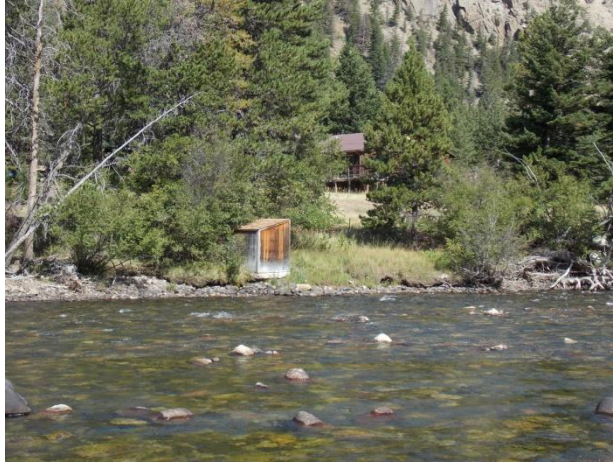
The pump house sits just above the low water level. A water mark on the exterior of the pump house indicates a recent high water event. The concrete foundation of the pump house is scouring. Downstream from the pump house, approximately 100 feet of old rock rip-rap lines the bank.

Old pump house on the west side of the river. White stain indicates a high water mark.

Recommendation: Remove the pump house if no longer in use. Relocate it further up the bank if it is still being used.

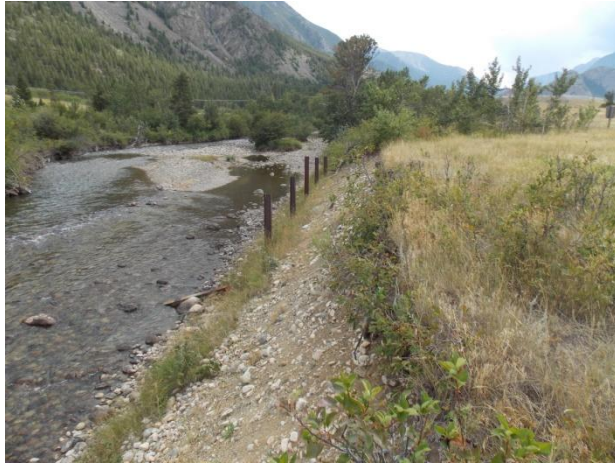
Eight steel pilings line the toe of an eroding terrace bank (~ 12 feet high) on the west side of the river. Several pilings are upright; others have fallen into the river. These pilings may have been part of a bank stabilization effort or part of an old river crossing. The pilings create a potential safety hazard to floaters.

Steel pilings along the toe of a high terrace.

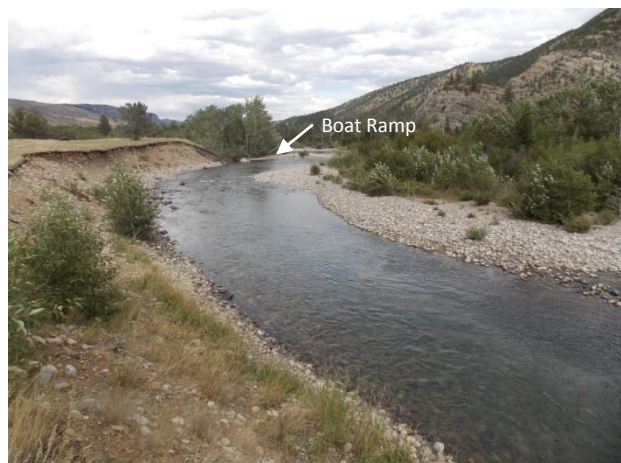
Eroding terrace bank upstream from the Old Nye Fishing Access Site. The river is slowly moving towards Highway 49.

Recommendation: Monitor the migration of the river towards the highway to determine if and when future bank stabilization measures may become necessary.

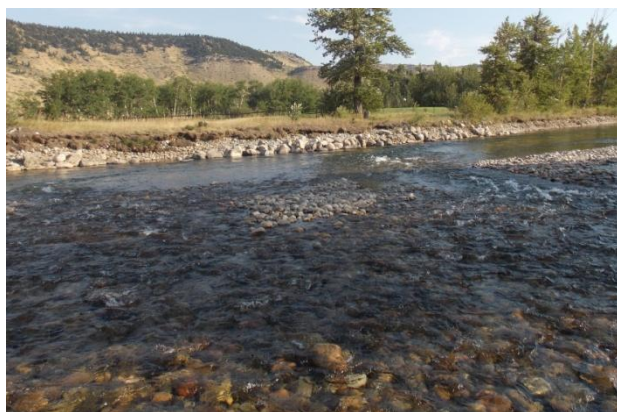
Rock rip-rap armors 220 feet of the west bank protecting a pasture, golf green and pond on the floodplain. The rip-rap consists mainly of round cobbles and small boulders (1 – 3 feet diameter). The upper end of the rip-rap (~ 60 feet) is intact and functional; the lower 160 feet has scoured and is partially flanked. A mid-channel gravel bar is deflecting the current directly into the bank, increasing pressure on the failed rip-rap. The riparian vegetation along the river has been cleared making this bank vulnerable to accelerated erosion. This bank will probably continue to erode during high water events.

Scoured rock rip-rap on the lower end of Site SW-17. A mid-channel gravel bar deflects the current directly into the bank.

- 1) Repair 80 – 100 feet of bank rip-rap where the river current is directly hitting the bank. Plant cottonwood and willow cuttings behind the rip-rap for long-term stability; or
- 2) Monitor the progress of the bank erosion to determine if and when bank stabilization measures warrant the expense.

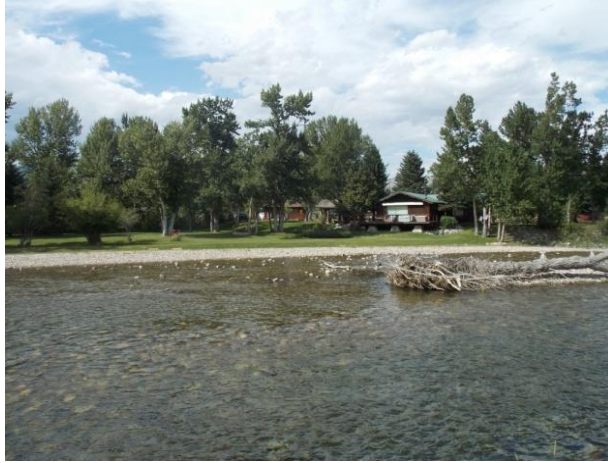
Individual small tract impacts to channel stability, in-stream flow, and water quality are usually minimal, but cumulatively they pose a significant risk to the Stillwater River.

Small tracts: house on low floodplain with landscaping to the river's edge.

Recommendation: Develop and implement a small tract outreach and assistance program to help landowners better understand how to minimize their impacts on the river. Program topics would include noxious weed management, water rights, septic maintenance, native riparian vegetation, suitable building locations, and basic river dynamics.

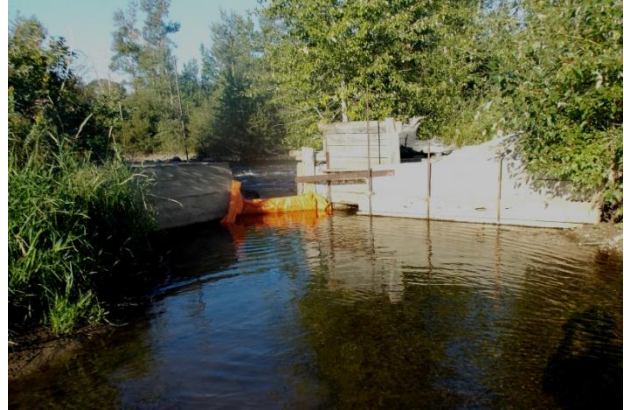
Irrigation headgate on the east side of the river. The structure is located on an open side channel along a braided section of river below the Castle Rock Fishing Access Site. The headgate has a concrete headwall with a wood slide gate and bypass outlet. The wing walls and outlet apron footings are being scoured. The existing by-pass outlet is too narrow for most floating debris to pass. Debris jams place excessive pressure on the structure and the upstream channel bank. It is also a hazard to clear when the water is high.

Irrigation concrete headgate and bypass structure on side channel.

Recommendation: Replace the entire structure using a design that will include a much wider bypass outlet to pass woody debris.

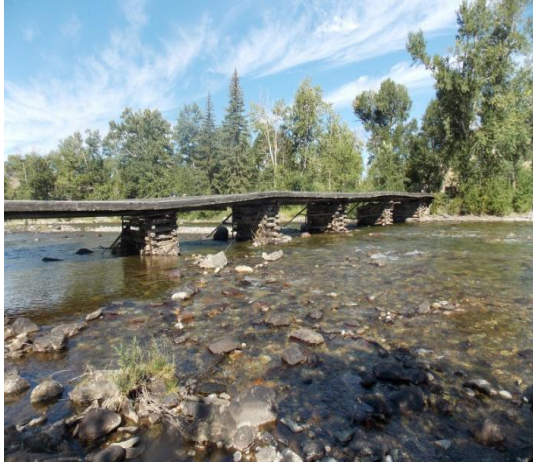
Old wood beam bridge that is 170 feet long. The abutments and four mid-channel bridge supports are log/steel pipe cribs partially filled with rock. The bridge supports are in poor condition and appear to be unstable. They are currently shored up with steel pipes on the upstream side of the bridge. A mid-channel bar has formed upstream from one of the bridge supports. This bridge is a hazard and is probably not suitable for vehicle use.

Old wood bridge with log/rock crib mid-channel supports and abutments.

Recommendation: Remove the old bridge from the river before it collapses. Prior to removal, contact the Montana State Historical Preservation Office to document the structure because it is the last remaining wood crib bridge on the Stillwater River. All material should be carefully removed from the active river channel and disposed of off-site. A new bridge design should incorporate a total span of the river, preferably without any mid-channel supports.

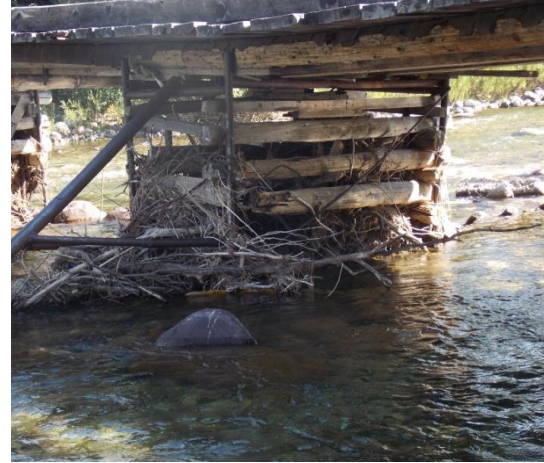
Log bridge supports are in poor condition. Steel pipes are being used to shore up the bridge.

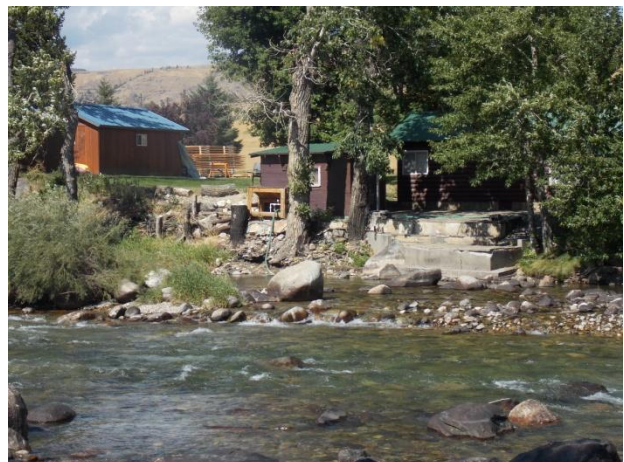
Small tracts: buildings on the river's edge. Most small tract landowners have placed pumps in the river for domestic irrigation.

Recommendation: Develop and implement a small tract outreach and assistance program to help landowners better understand how to minimize their impacts on the river. Program topics would include noxious weed management, water rights, septic maintenance, riparian vegetation, suitable building locations, and basic river dynamics.

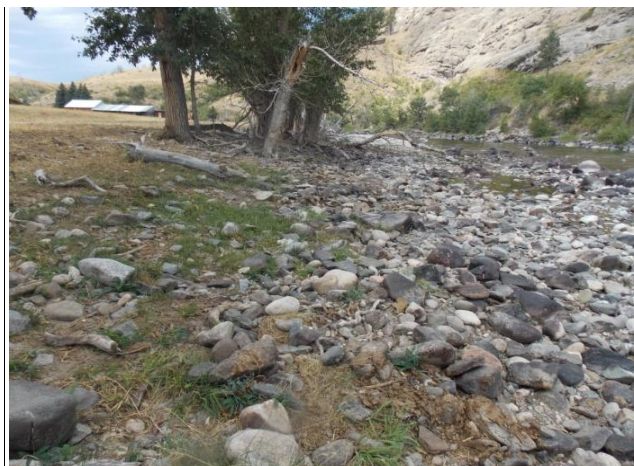
Riparian buffer being impacted by heavy livestock use.

Recommendation: Build a riparian fence (portable electric) along 1,000 feet of bank to allow the riparian corridor to recover. Incorporate a water gap or develop off-stream livestock water as needed. Planting young cottonwood cuttings would speed the recovery.

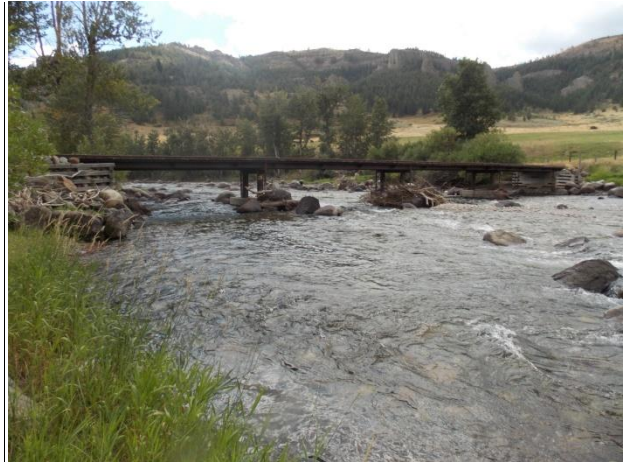
Bridge with mid-channel supports faced with large boulders.

Recommendation: When this bridge is ready to be replaced, construct the new bridge in the same location with as few mid-channel supports as possible.

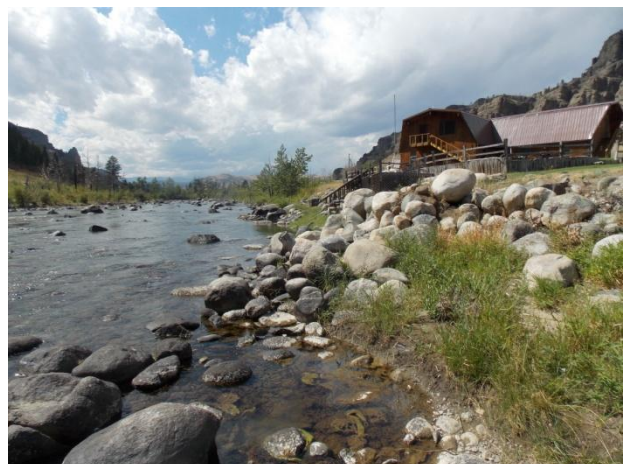
West Subdivision: buildings on the river's edge with large boulders in the foreground being used for bank stabilization. Many small tracts have domestic pumps placed in the river to irrigate landscaped yards.

Recommendation: Develop and implement a small tract outreach and assistance program to help landowners better understand how to minimize their impacts on the river. Program topics would include noxious weed management, water rights, septic maintenance, suitable building locations, and basic river dynamics.

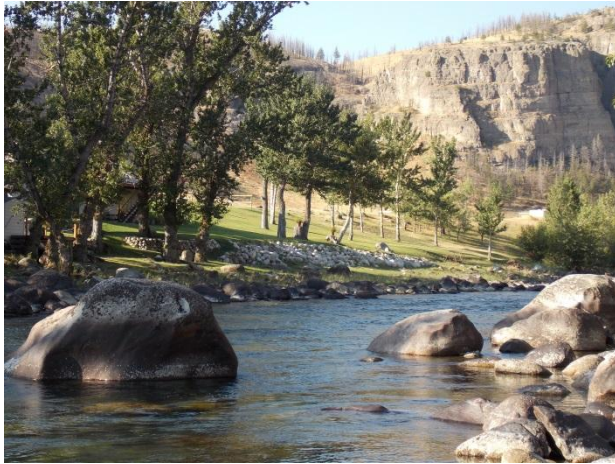
The Stillwater River Road (420) parallels the river along the north bank for about 0.3 miles. Sediment washing off the road during heavy run-off eventually reaches the river.

Native riparian vegetation often cleared to accommodate small tract landscaping.

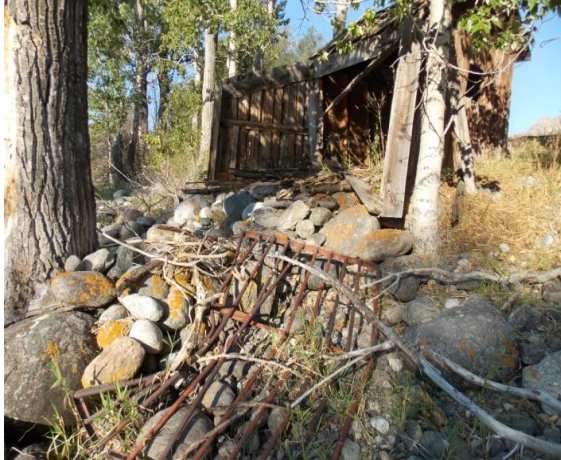
Individual small tract impacts to channel stability, in-stream flow, and water quality are usually minimal, but cumulatively they pose a significant risk to the Stillwater River.

The newly subdivided lands have not yet been fully developed. There are a few older sheds and buildings along the river that pre-date the subdivision.

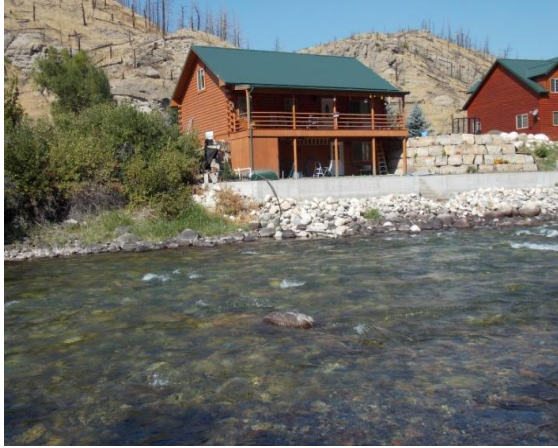
Individual small tract impacts to channel stability, in-stream flow, and water quality are usually minimal, but cumulatively they pose a significant risk to the Stillwater River.

The subdivision has a high number of retaining walls bordering the river. Most tracts have pumps in the river for landscape irrigation.

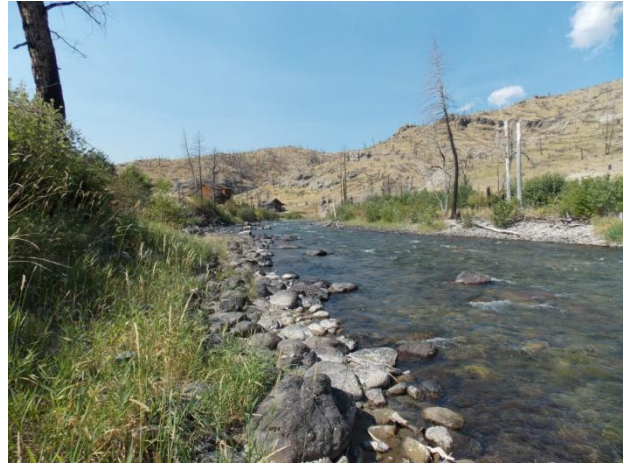
Riparian vegetation regrowth along the river banks and on the gravel bars following the 2006 Derby Fire.

Recommendation: Develop and implement a small tract outreach and assistance program to help landowners better understand how to minimize their impacts on the river. Since this subdivision is located on a porous alluvial fan, proper septic installation and maintenance are especially important. Noxious weeds have increased significantly since the Derby Fire. Tract owners need to cooperatively control noxious weeds in their subdivision.

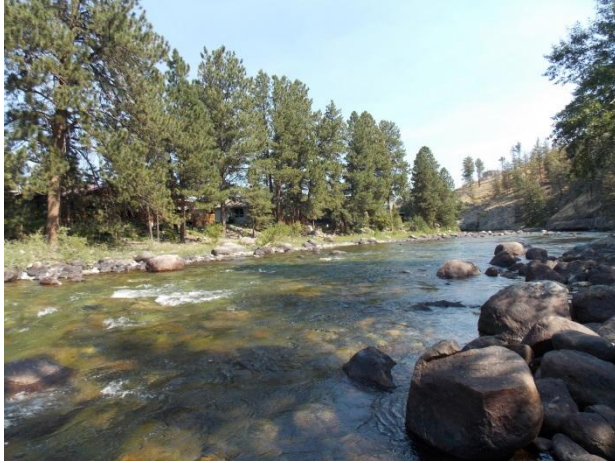
Individual small tract impacts to channel stability, in-stream flow, and water quality are usually minimal, but cumulatively they pose a significant risk to the Stillwater River.

Riddle's Cliff: riverfront houses have been built along an inside bend.

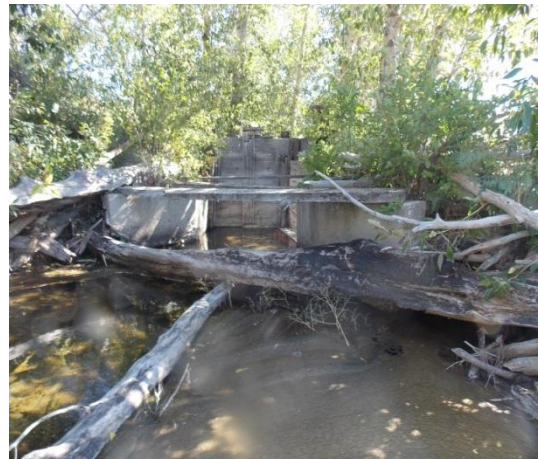
Old concrete and wood headgate with woody debris piled up in front.

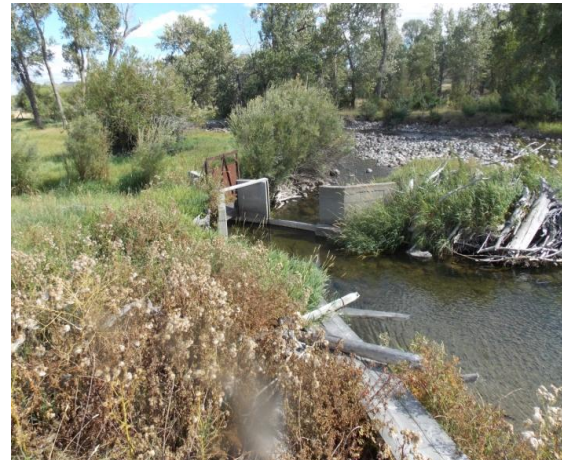
Old concrete headgate and metal slide gate. Woody debris piles up in front of the headgate during high water.

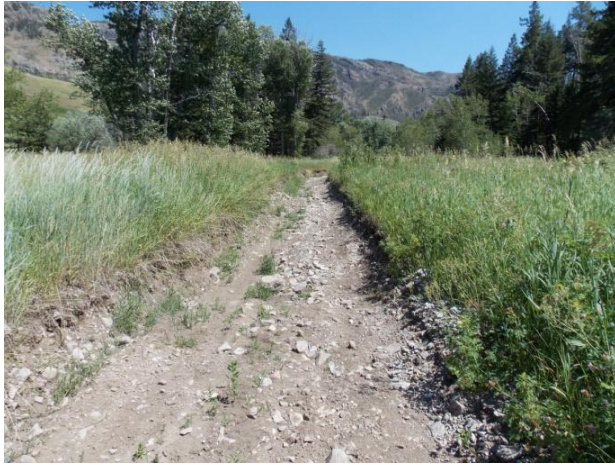
Scoured county road between Sites LP-3 and LP-4 caused by the 2011 flood.

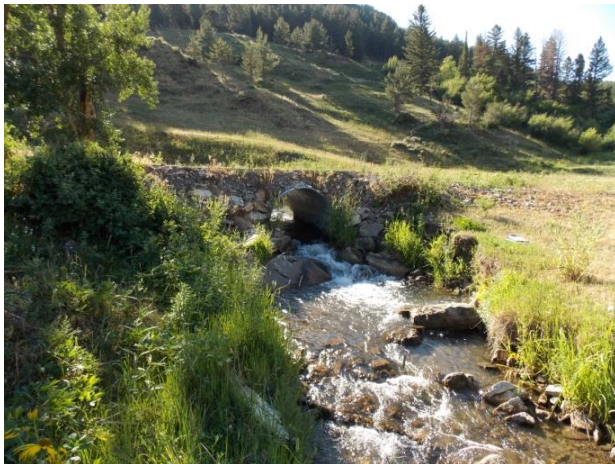
Culvert stream crossing on Lodgepole Creek serving as a channel restriction.

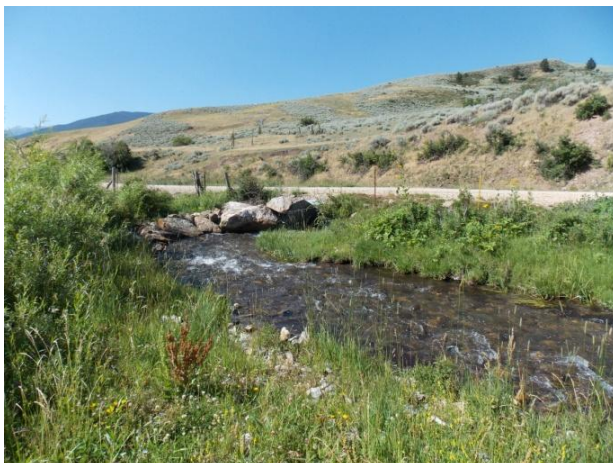
Culvert crossing located on a sharp bend. The culvert does not have the capacity to pass flood waters.

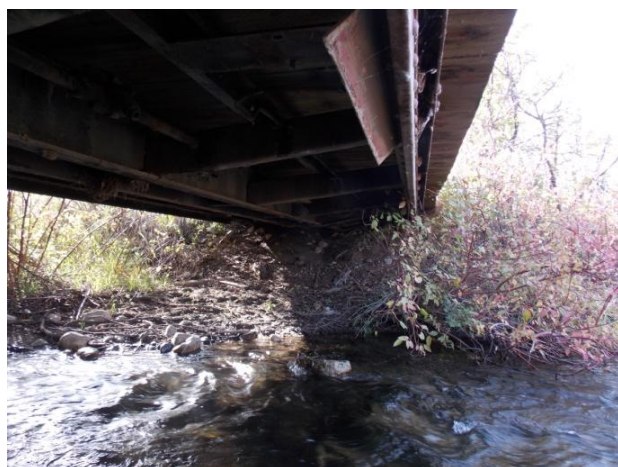
Bridge crossing on Little Rock Creek Road. The bridge rests on the ground and may be vulnerable to high flows.

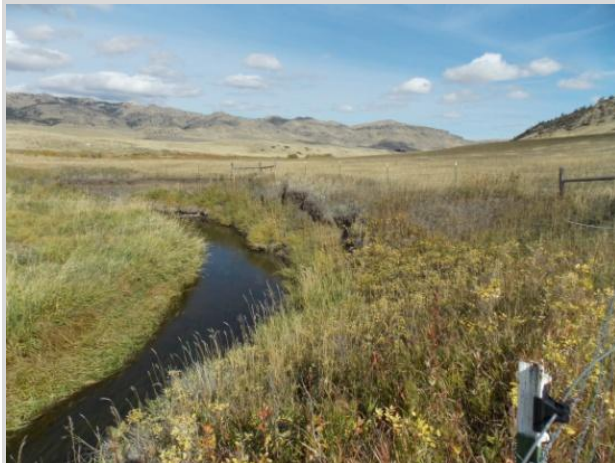
Minor terrace erosion next to an old hay field on the east side of Little Rocky Creek.
